Reconstruction of Nukata Drainage Pump Station of the Musashi Canal (Outline of the Reconstruction Work and Verification of CFD Analysis)

Abstract

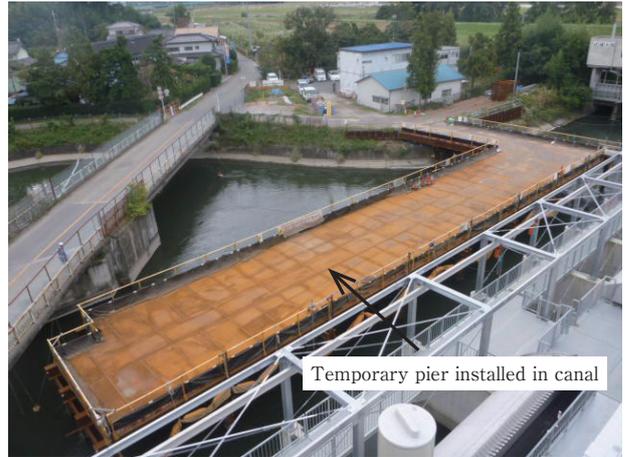
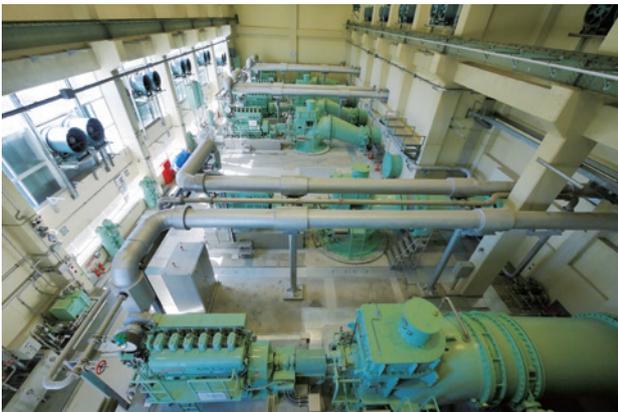
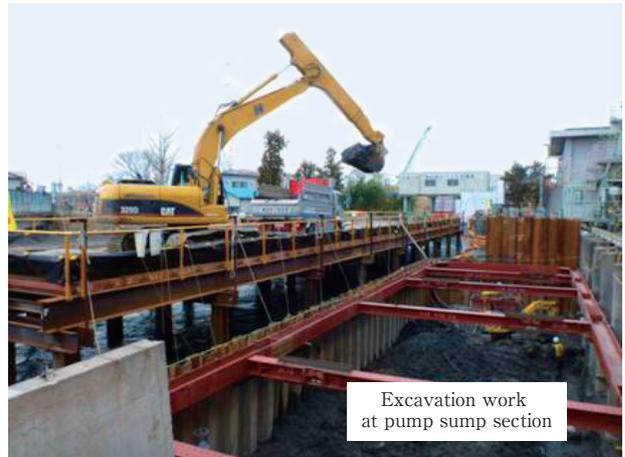
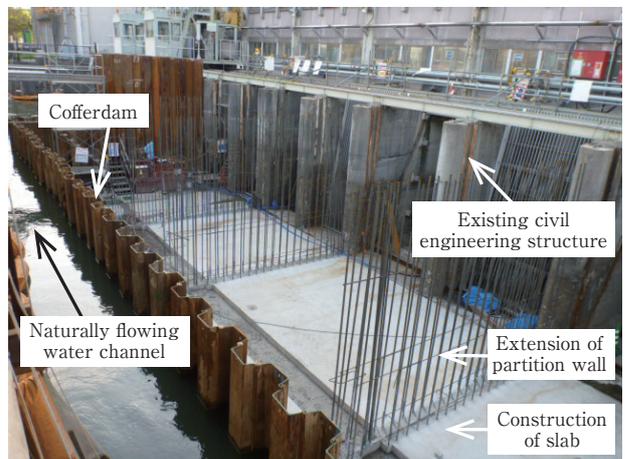
Fig. 7 Installation of temporary pier and cofferdam, and construction work in canal

Temporary pier installed in canal

Excavation work at pump sump section

Cofferdam
Existing civil engineering structure
Naturally flowing water channel
Extension of partition wall
Construction of slab

- (2) Installation of temporary pier and cofferdam in canal for drainage of pump sump section (**Figure 7**)
To install trash removal screens in the pump sump section, it was necessary to extend the existing civil engineering structures in the direction of the inflow side and construct a slab and partition walls in the canal. Therefore, we installed a temporary pier in the canal so that heavy machinery could be used on it for crane work and excavation. Moreover, we also conducted temporary water shielding by means of a cofferdam to drain the pump sump.

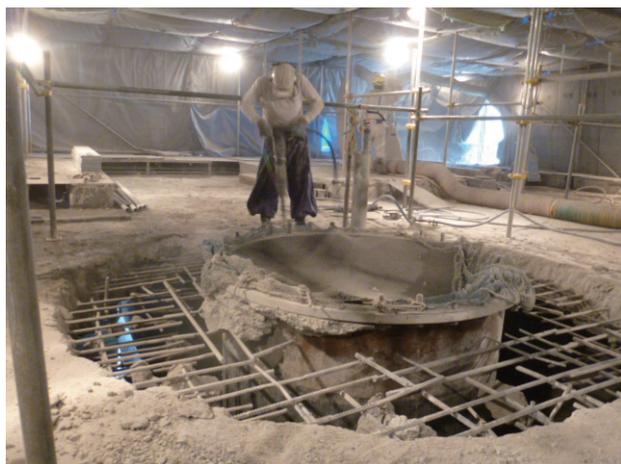
(a) Removal of existing equipment

Fig. 8 Reconstruction of machine foundation

- (3) Reconstruction of foundation for machinery (**Figure 8**)
The pump facilities to be newly installed during the reconstruction work were expected to have different specifications from those of the old ones. For example, the new main pumps have a vertical shaft, as well as a larger bore due to increased discharge capacity. In addition, the output of the prime mover is also different from before. Consequently, we removed existing machines along with their substructures by cutting the existing concrete, while leaving the existing reinforcing bars of civil engineering structures as they are [Fig. 8 (a)]. After that, openings and substructures tailored to the renewed machines were newly constructed [Fig. 8 (b)].

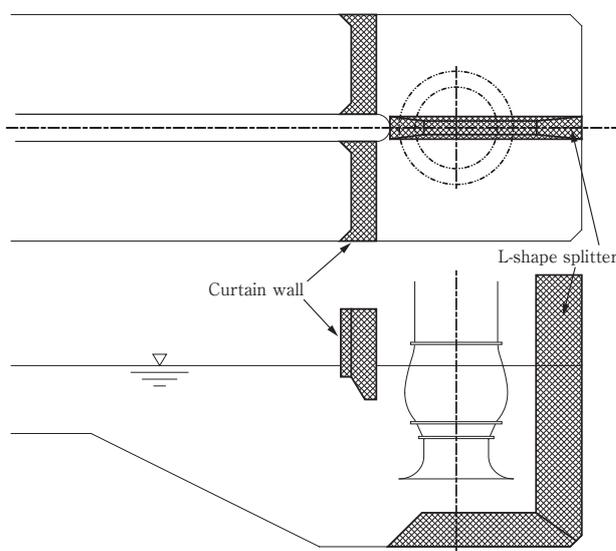
Fig. 11 Configuration of vortex suppression devices

a model testing, in order to study the configuration of anti-vortex devices. Fig. 11 shows the configuration of vortex suppression devices optimized using CFD analysis. On top of that, this time we proved the effectiveness of the vortex suppression devices configured with the help of CFD analysis, based on the data obtained through the test operation of real equipment during the comprehensive commissioning conducted prior to the completion of the renewed Nukata Drainage Pump Station. We also checked the validity of the CFD analysis we conducted.

As the pump renewal work was expected to increase discharge capacity, we deemed the countermeasures against vortices generated in the pump sump (**Figure 11**) as the most important theme to be addressed. So, we provided devices to cope with these pump sump vortices with use of CFD analysis, as we presented the outline in the previous report²⁾. This time we report on the results of a verification of CFD analysis conducted at the time of the field commissioning.

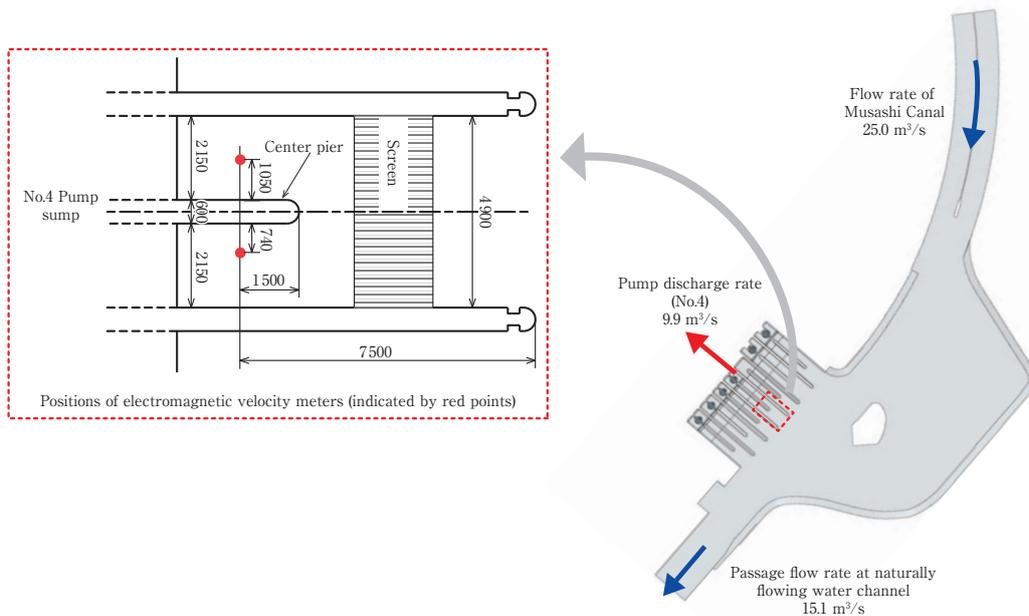
Fig. 12 Field test conditions

Figure 12 shows the situation of inflow and outflow of water from the balancing reservoir at the time of the field test. The pump’s discharge capacity was calculated based on the pump performance curve obtained in a factory performance test, the water level conditions at the time of the field test, and piping and valve-related losses. As the discharge capacity of the pump exceeded the rated value, the test was conducted under conditions where vortices were likely to occur in the pump sump.

velocity meters were used to measure the flow velocity in the pump sump. One velocity meter was installed in each of the left and right water channels divided by a center pier, as shown in Fig. 12.

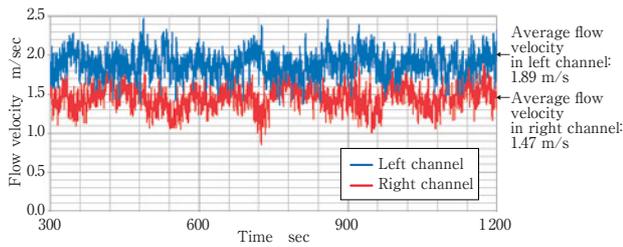
Fig. 13 Flow velocity in No.4 pump sump

Figure 13 shows the time variations of the flow velocity in the pump sump (stream-wise component in the sump) when the No. 4 pump is independently running. Data revealed that the flow velocity tended to be higher in the left channel than in the right when the pump was viewed from the upstream side. The average flow velocity within the time range indicated in Fig. 13 was 1.89 m/s for the left channel, and 1.47 m/s for the right channel. Then, these averages were deemed as representative flow velocity values and converted to flow rate, on the assumption that no water-level difference occurs between the left and right

channels; as a result, the flow in the left channel accounted for 56% of the total, and that in the right channel 44%.

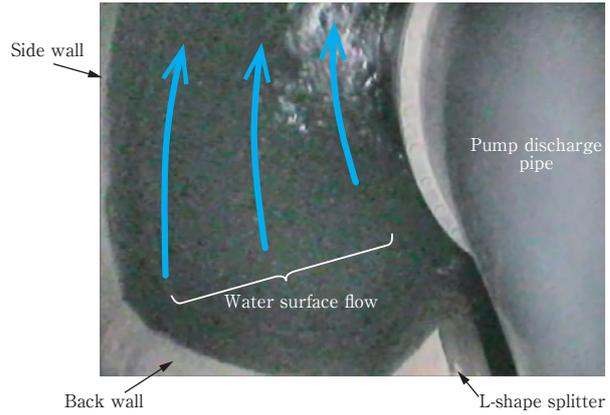
Fig. 14 Water surface flow adjacent to pump suction pipe

Figure 14 shows the water surface flow around the pump suction pipe, which was observed by means of an industrial endoscope while the pump was in operation. We found no swirling flow during the test run, and confirmed that no air-entraining vortices would be generated.

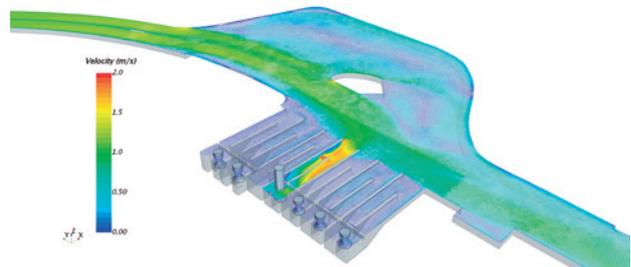
Fig. 15 CFD analysis results of pump sump along with balancing reservoir

We conducted a steady state analysis using the Reynolds-averaged Navier-Stokes (RANS) model, not taking water surface fluctuations into account. **Figures 15** and **16** respectively show a vector diagram of flow velocity in the balancing reservoir and an enlarged view of inflow into the pump sump. The proportion of the flow in both the channels was 58% for the left channel and 42% for the right channel, fairly consistent with the results of the field test.

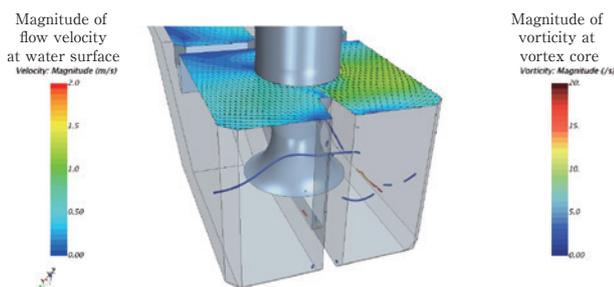
Fig. 17 CFD analysis results of pump sump

Figure 17 presents the distribution of the velocity vectors at the water surface, as well as the vortex core lines, in the pump sump. Although several vortex cores are observed, they are not harmful, showing that the vortex suppression devices are effective. Flow patterns at the water surface are also highly consistent with the observation of the actual equipment (**Fig. 14**); this means that the flow conditions during the actual equipment test were successfully reproduced with good accuracy, by means of the large scale CFD analysis on the balancing reservoir and pump sump.
