Technical Information

Motor Protection (Auto-Cut)

Mechanical Seal and Ball Bearing

Mechanical Seal Sectional View (1/2)

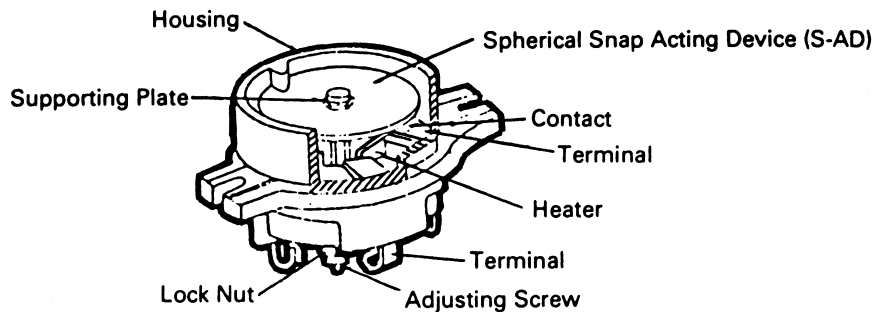
FIGURE 1

There are two different types of Auto-Cuts, one is a single pole model that is used for single phase motors and the other is a three pole model that is used for three phase motors. Figure 1 below illustrates the construction and operation of the three phase model.

Composition: 3 sets of contracts, 1 Snap-Acting Disk, 3 Heaters, 3 Terminals and 1 Calibration bolt and nut.
The above parts are encased in a Bakelite housing.

The Auto-Cut is installed directly over the winding of the motor, where it not only senses over heating of the winding but also excess amperage draw by each of the three windings.

Figure 2 shows the Auto-Cut in its normal operating condition (Contacts closed). When actuating temperature is reached, the Snap-Acting Disk snaps open to interrupt the circuits as shown in figure 3.

When the motor temperature cools down to the safe operating temperature, the Snap-Acting Disk resets automatically to the original position as shown in figure 2, and the motor restarts.

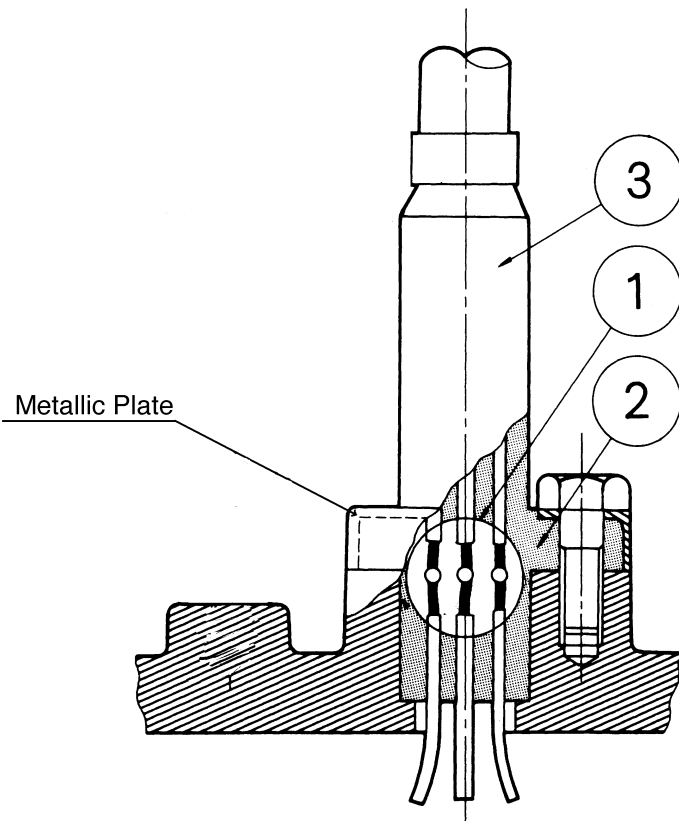
①	Water cannot leak into motor even if the cable is cut or damaged because cable leads are soldered and then isolated by rubber sealing, thus preventing any capillary action past that point.
②	Thick moulded shoulders bolted to motor dome provide exceptional strength and form a strong compression seal.
③	Cable resists bending forces by increased cable diameter.

1/2 to 10HP

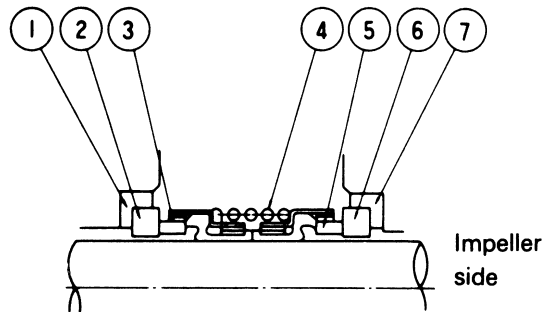
Type A-15

Typical construction and materials are as follows:

DSHU, 1/2 to 1HP

DVSHU, 1/2 to 1HP

NO.	PART NAME	MATERIALS (HOT WATER PUMP) DSHU, DVSHU	NO. FOR 1 SET
1	Packing	Viton Rubber	1
2	Floating Ring	Silicone Carbide	1
3	Seal Ring	Silicone Carbide	1
4	Spring	304S.S	1
5	Seal Ring	Silicone Carbide	1
6	Floating Ring	Silicone Carbide	1
7	Packing	Viton Rubber	1

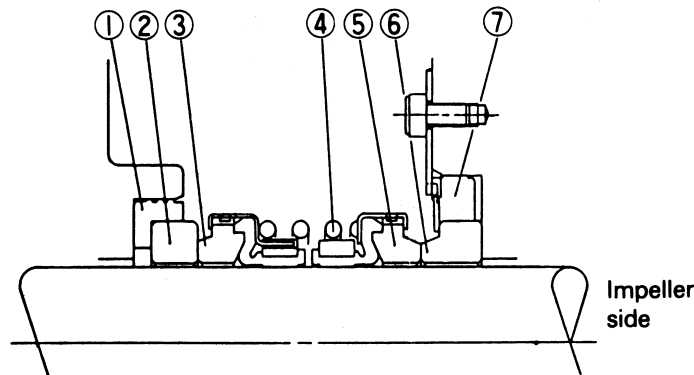
Type A-20, A-30, A-35
DSU, 2 to 5HP
DSHU, 2 to 5HP
DVSU, 2 to 5HP
DVSHU, 2 to 5HP

NO.	PART NAME	MATERIALS DSU, DVSU	MATERIALS (HOT WATER PUMP) DSHU, DVSHU	NO. FOR 1 SET
1	Packing	N.B.R. Rubber	Viton Rubber	1
2	Floating	Ceramic	Silicone Carbide	1
3	Seal Ring	Carbon Graphite	Silicone Carbide	1
4	Spring	304 S.S.	304 S.S.	1
5	Seal Ring	Silicone Carbide	Silicone Carbide	1
6	Floating Ring	Silicone Carbide	Silicone Carbide	1
7	Packing	N.B. Rubber	Viton Rubber	1

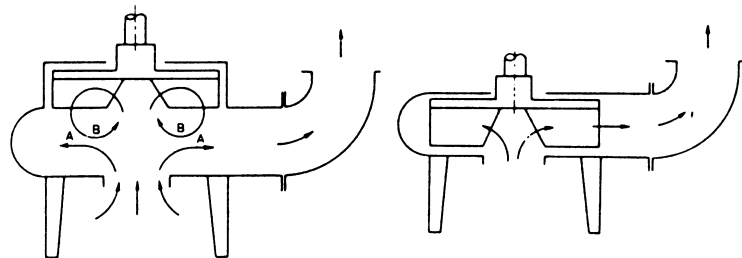
When the vortex impeller rotates in the casing, it generates primary vortex (B) and secondary vortex (A) as shown in the drawing, and then pumps up water:

Vortex Pump

ORDINARY NON-CLOG PUMP

- a) As there is a large space between the impeller and the suction cover and there are no obstacles in the water passage, sewage can be discharged without clogging.
- b) Ebara's unique hydraulic design of impeller and casing provide highly efficient performance which compares favorably with ordinary non-clog pump in spite of the large space.

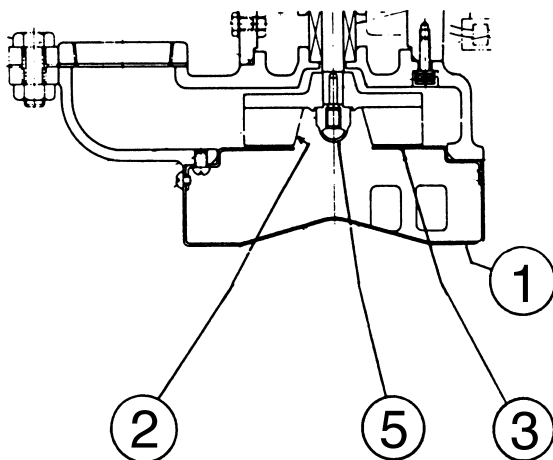
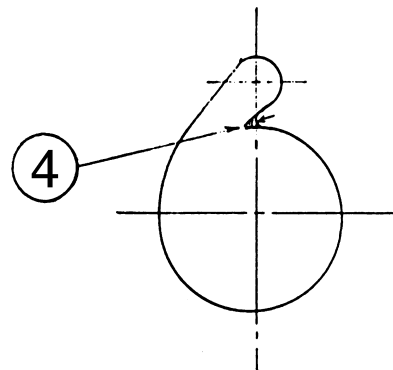
Shape inlet portion of the impeller blade as described below. The inlet edge of the impeller vanes are angled toward the impeller periphery so as to facilitate the release of objects that might otherwise clog the pump.

Eliminate sharp points on impeller and impeller nut (use rounded impeller nut).

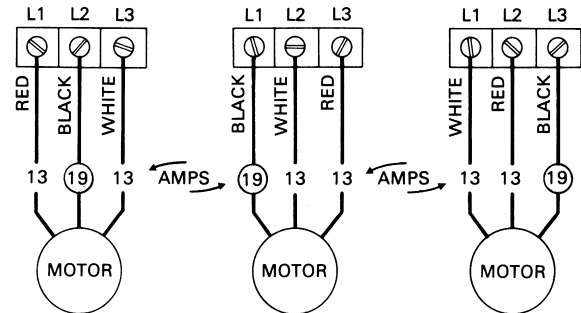
If the unbalanced leg follows the same wire in the drop cable from the pump, regardless of which position it is connected to on the control terminals the fault would most likely be found in the stator windings or in the stator leads to drop cable connections.

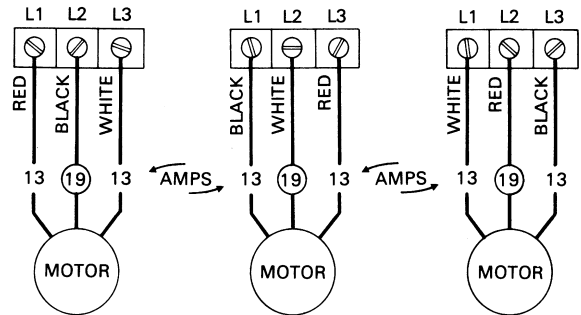
If the unbalanced leg remains related to the same terminal in the control box regardless of which wire is connected to it, the fault would most likely be found in the power supply or possibly poor connection in the control.

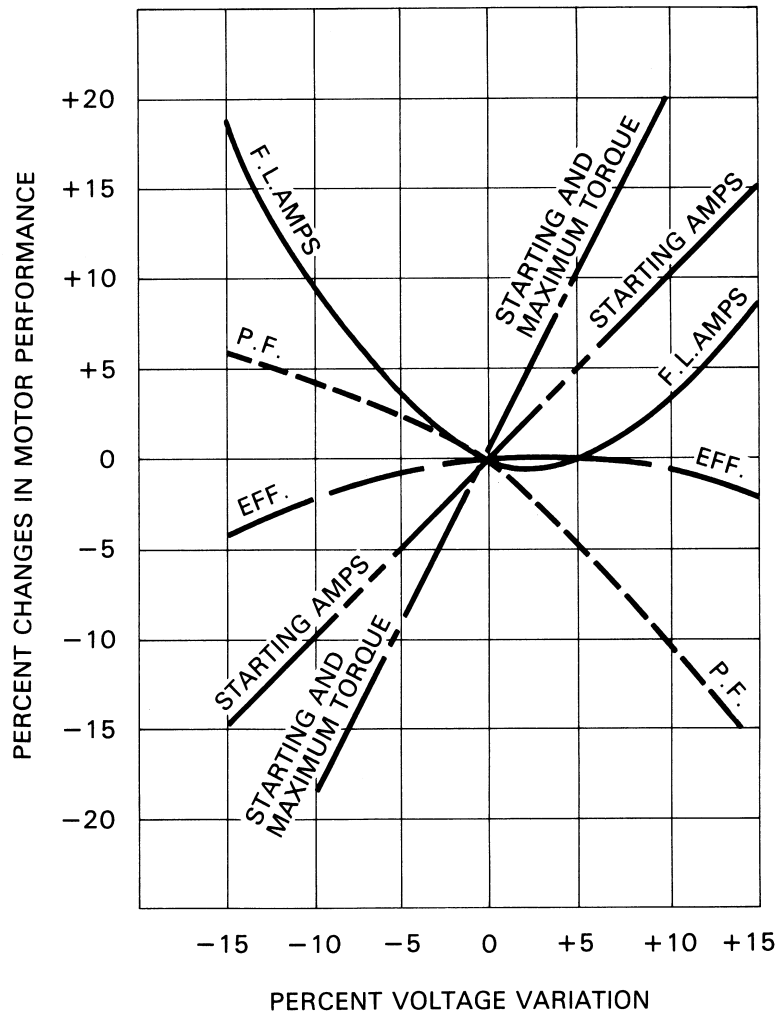
Effect of Voltage Variation on Induction Motor Characteristics
